TROUBLESHOOTER / FOR DUAL FLUSH MECHANISM

Ref : A10385 03/2005

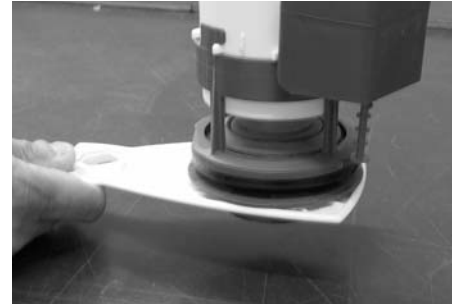
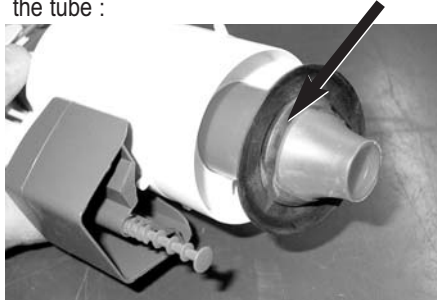
WATER LEAKS ON THE FLOOR

The base nut is not screwed sufficiently :

Re-tighten the base nut.

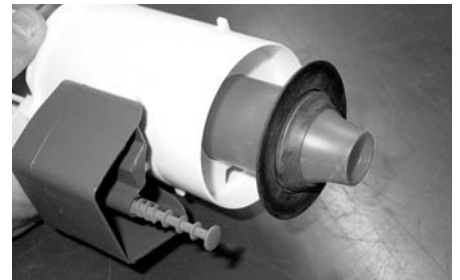
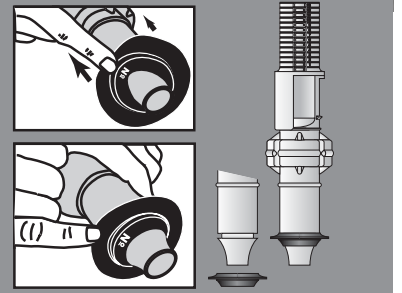
The washer is not correctly positioned on the tube :

Position it correctly.

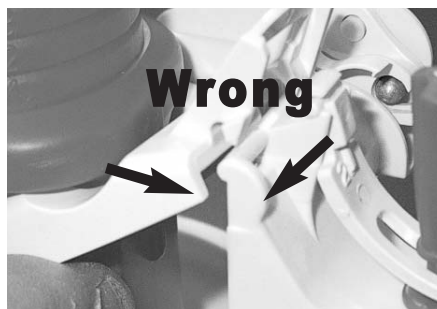
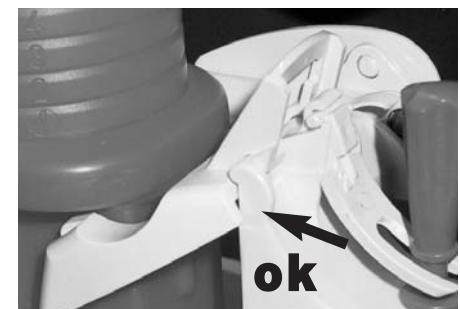
WATER LEAKS IN THE PAN OR THE FULL FLUSH DOES NOT WORK

The " fork " support is not correctly clipped into the 2 notches :

Clip it correctly.

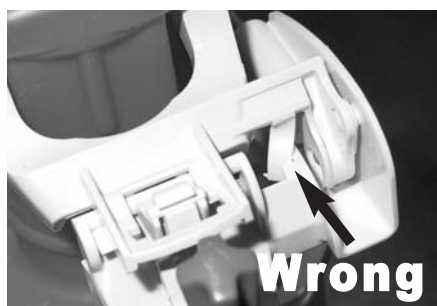
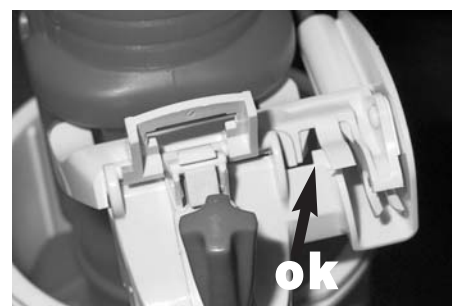
WATER LEAKS IN THE PAN

The overflow remains in high position because the small plastic flap is badly positioned

Position it correctly

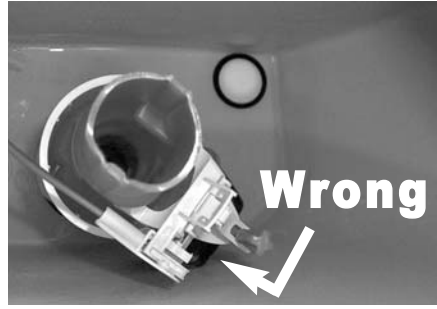
**ONLY THE HALF FLUSH IS ACTIVATED,
THE FULL FLUSH DOES NOT WORK**

The ball float should not touch the cistern wall :

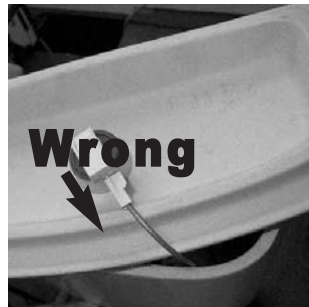
**YOU NEED TO GET INTO THE CISTERN
(DAMAGED CABLE, FAULTY WASHER...)**

To get into the cistern, do not turn the lid upside-down or pull the cable :

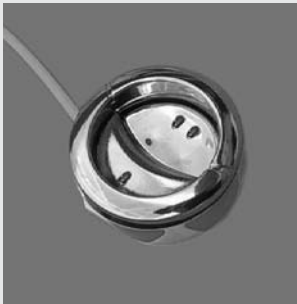
THE PUSH BUTTON REMAINS IN THE "PUSH POSITION" WHETHER HALF-FLUSH OR FULL-FLUSH.

The cable control is wrongly clipped onto the threaded base of the push button :

The cable control should be clipped correctly onto the push button base.
